**Certified Appraisal Report of N350AJ,
A 1990 Beech Super King Air 350**

**Prepared by:
Tennessee Aircraft Appraisals
June 29, 2001**

NATIONAL AIRCRAFT APPRAISERS ASSOCIATION **AIRCRAFT APPRAISAL REPORT**

Serial No. FL-22 **Reg. No.** N350AJ **Yr. Mfg.** 1990

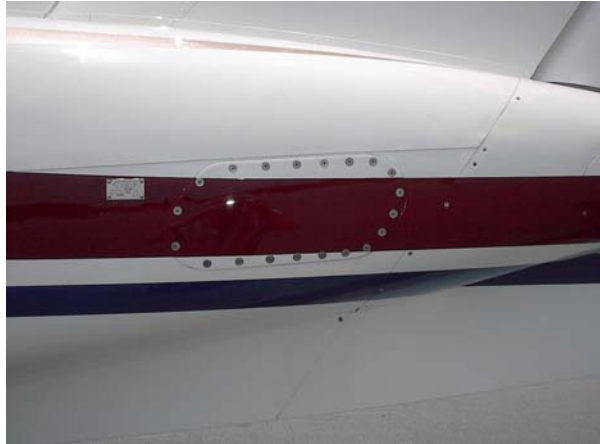
There are thirteen seats on the aircraft; two pilots' seats and then two sets of club seats on each side. The last three seats are a belted potty seat facing sideways and then two jump seats in the rear of the aircraft. The access doors on the exterior of the aircraft have stainless steel screws instead of painted screws. This adds to the executive effect (see picture).

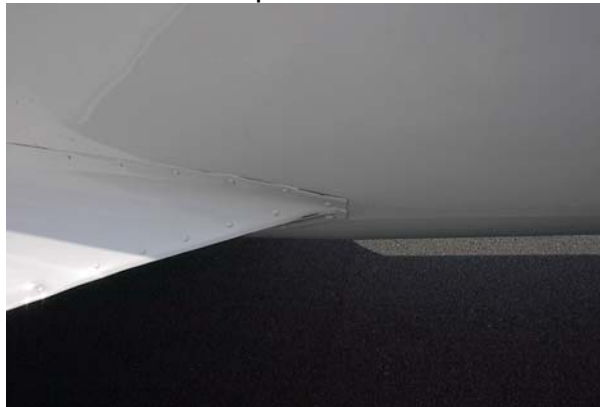
The airframe is almost flawless. There are a couple of small gaps between rivets on the left fuselage/wing trim piece at the rear along with a small separation. These are pictured. The right wing trim is okay. Otherwise there were no other noticed defects. There is a log book note that on 5/10/00 #13 LH & RH access door cracks were stop drilled.

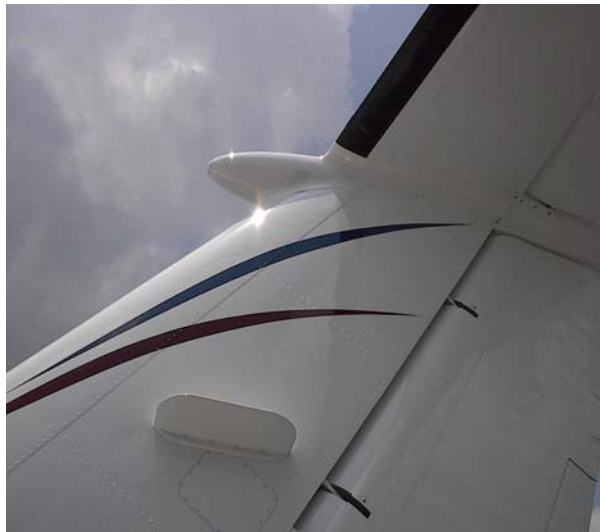
blue G5003 and PPG pearl fawn 27815. There is excellent adhesion between the substrate and the coating. The striping is straight and without flaw. All surfaces are of a high gloss finish. The painted surface behind the engines is very dirty but appears that it would clean up without paint deteriorating. There are two flaws in the painted areas: At the top left of the tail trim there is a 4" X 2" paint chip that has been repainted with an excellent color match. The color match and the height of the area (fifteen feet vertical) make it difficult to detect (pictured).

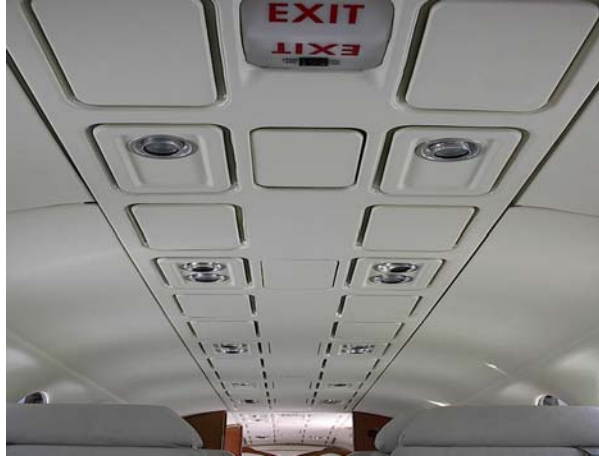
The interior has a very executive look and feel. The headliner is exceptional (pictured). It is a #3700 ivory ultra/leather. The carpet is pembroke from Sandpiper Interiors. It has a runner that covers the walkway. The carpet underneath is flawless. The seats are a leather aeronappa dove. There are a couple of seats with small marks on them but otherwise they are luxurious. Even the side panels are covered with fabric- myers contrac fiber whose pattern is everglade and color is shadin. There is cabinetry throughout with no flaws. There are four game tables and a couple of magazine racks. There is a sliding door which separates the potty seat (and jump seats) from the rest of the cabin. The door cable covers have normal wear.

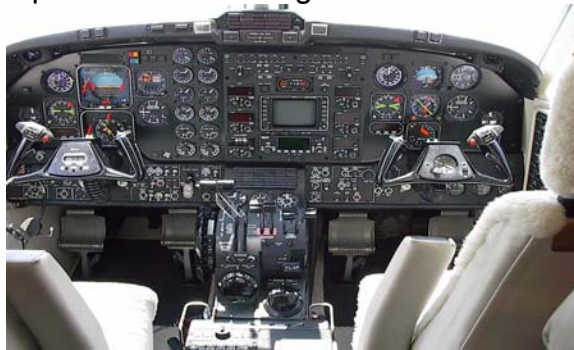
The cockpit area is flawless. There are no paint chips around any avionic including the pedestal where chips are usual. The dashboard has no apparent marks and even the pilots' seat coverings are in excellent condition.

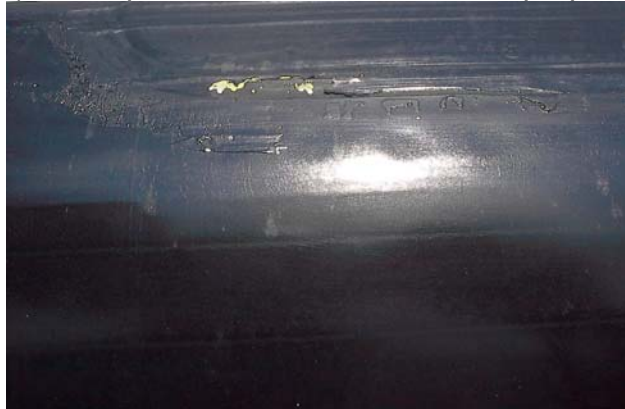
Comments: On 6/3/99 Boots West Aviation removed all patches and restored all holes on the deice boots. The wing deice boot trim partially covers an access door on the wing. There is some flaking around the access door at the taped area (see picture) as well as minor frayed edges but all are in good condition. The deice surfaces for the most part still have a glossy surface and are still soft. The prop deice boots are in good shape but have lost some gloss. On 6/7/99 Aeropropeller (PTY) Ltd. replaced the deice kits on the propellers.
